CHAPTER-I

SOCIAL, GENERAL AND ECONOMIC SECTORS (Non-PSUs)

Solid Waste Management (SWM) is a challenging issue for Goa given its small size, high population density and large tourist influx. Health, hygiene, environment and aesthetics are all impacted by SWM policy and strategy.

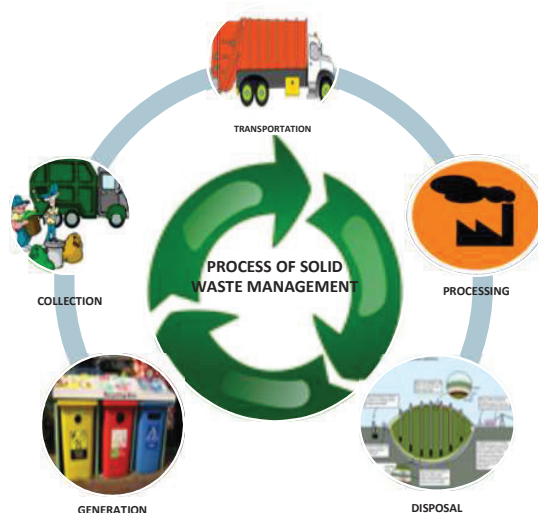
Successful SWM strategy requires that all the waste that is generated should be properly and fully collected at source. Thereafter, all of it should be transported and safely processed in accordance with the principles of reduce, reuse and recycle. The inert material remaining after processing has to be safely disposed. The process of SWM is depicted diagrammatically below:

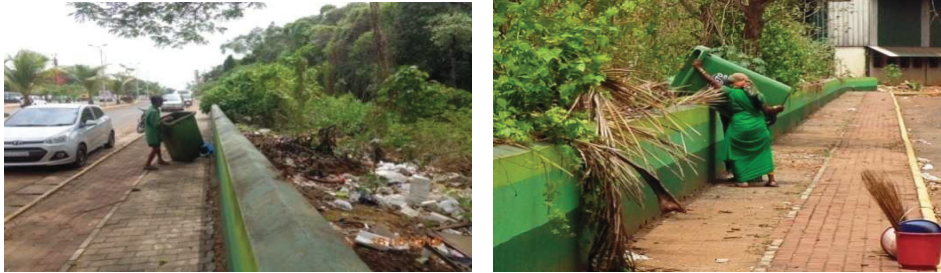
between May and July 2018. Audit even noticed sanitation workers at Economic Development Corporation (EDC) complex within CCP jurisdiction dumping waste in nearby vegetations as shown in the photographs below.

Sanitation workers at EDC complex dumping collected waste in vegetations (18 May 2018)

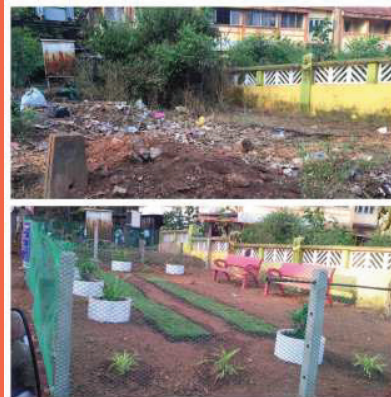
During 2018-19, Mapusa MC adopted a unique method to stop littering/dumping at black spots (where garbage is thrown regularly by public at large) by turning 14 such spots into beauty spots

'Before' and 'After' status of black spot near Government Primary School, Xelpem, Mapusa

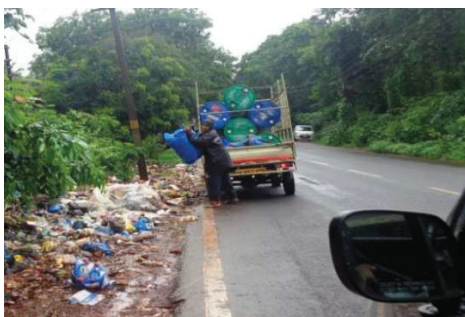
In order to seek an assurance whether highway cleaning works were done effectively and efficiently by the contractors, Audit covered seven stretches of highways spread over a distance of 172 km in three zones (North, Central and South) along with the officials of GSIDC and the contractors on 10 and 11 July 2018 and found solid waste dumped at 52 locations. Two of such instances are depicted in the photographs below.

Karaswada to Sanquelim road stretch
(10 July 2018)

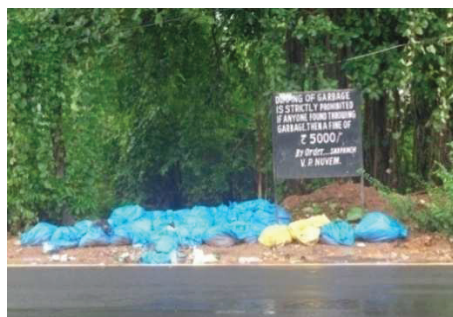
Waste along Panaji to Margao NH
(11 July 2018)

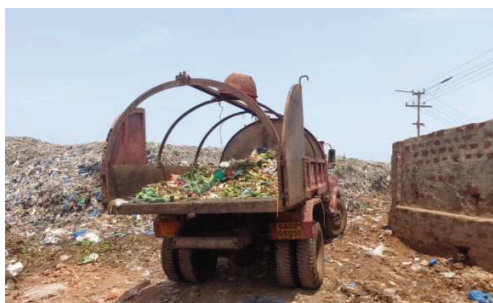
During site visits of four³² dumping sites and Solid Waste Treatment Plant (SWTP) at Saligao, Audit observed that the garbage was being transported to dumpsites in open vehicles while leachate was leaking profusely from the trucks carrying garbage to SWTP, as depicted in the photographs below.

Open vehicle at the dumpsites of Mormugao
(31 May 2018)

The GSPCB issued a show cause notice (December 2018) to the concessionaire running the SWTP at Saligao for ferrying garbage to the plant without protective covers and leachate collection tanks. The concessionaire, however, contested that as per the scope of work, they were required to only treat the waste as received at the plant from various locations through collection and transportation agencies authorised/directed by GWMC/DSTE/GSIDC *etc.*

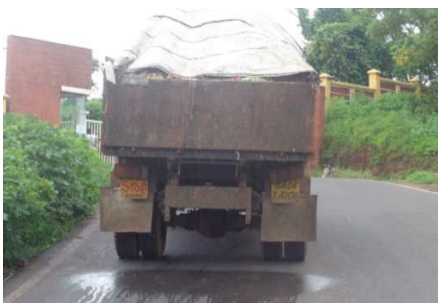
Leakage from truck at SWTP, Saligao
(24 August 2018)

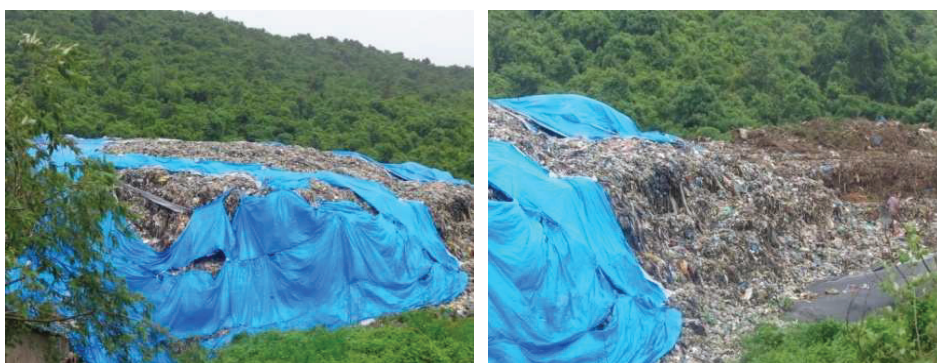
As of November 2018, the dump at Sonsoddo grew to a staggering 1,00,000 tonnes (measuring 16.5 meters vertically) with a daily addition of around 20-25 tonnes, and continues to pose environmental and health hazard.

As a stop-gap measure, the Margao MC laid plastic covers over the dump which were left in tatters and dislocated, due to vagaries of weather, as shown in photographs below.

Garbage dumps at Sonsoddo, Margao (26 June 2018)

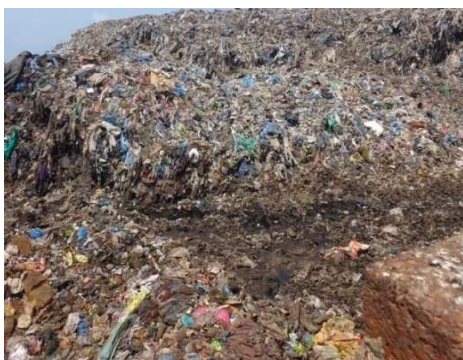
- Waste was seen burnt at many locations in the jurisdictions of CCP, near landfill site of Pernem MC and near dumpsite of Curchorem-Cacora MC.
- No fire protection equipment was installed by the ULBs despite incidences of fire at the waste segregation and baling station at Cacora under Curchorem-Cacora MC (January 2014) and Sonsoddo dumpsite under Margao MC (June 2017 and May 2019).
- Waste was being handled manually without adequate protective gears like gloves, gumboots, face masks *etc.*
- Leachate was seen flowing⁶² at the dumpsites/processing plants posing threat to surface and ground water as depicted in photographs below.

**Leachate at dumpsite of Mormugao MC
(31 May 2018)**

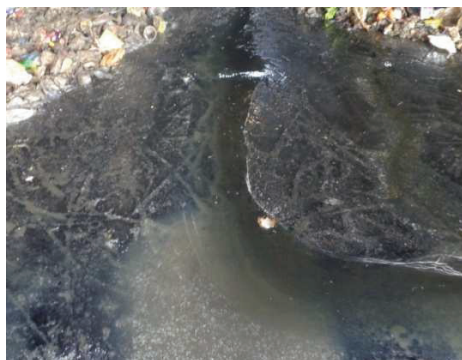
**Leachate at processing plant of Margao MC
(26 June 2018)**

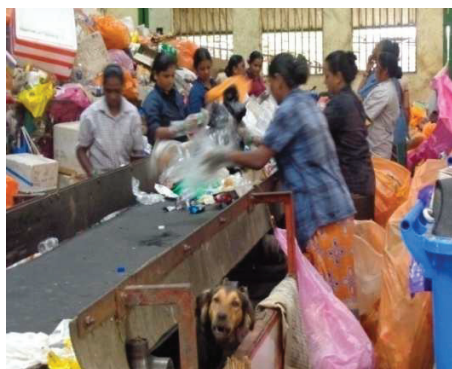
- Waste processing and disposal sites were not protected and stray animals were seen roaming⁶³ inside.

Segregation and baling station of CCP
(17 May 2018)

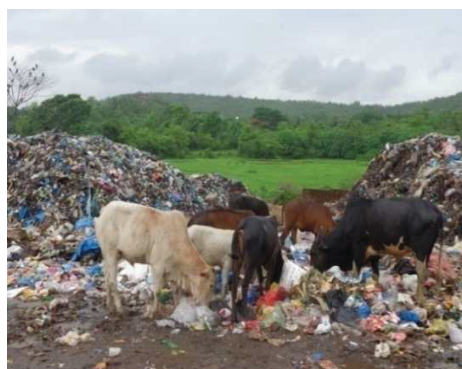
Dumpsite at Cacora
(08 June 2018)

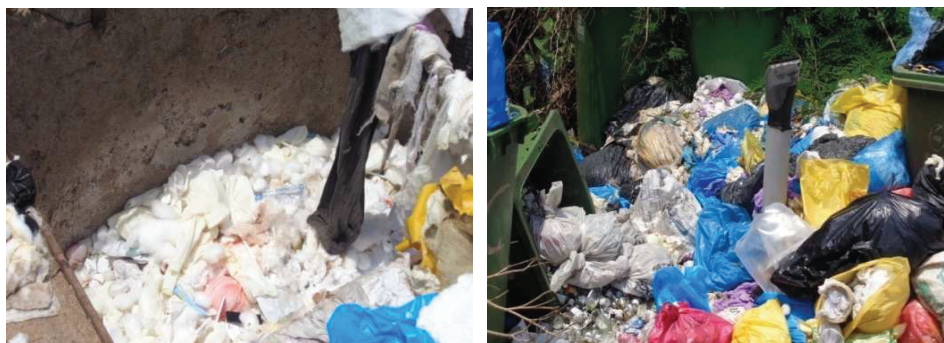
Site visit (May 2018) to dumpsite at Sada under Mormugao MC in South Goa revealed BMW dump consisting of blood-stained cotton, flesh, plaster casts, syringes, medicine bottles *etc.* in open in contravention of BMW Rules, 2016 as shown in the photographs below.

Biomedical waste at Sada dumpsite under Mormugao MC (31 May 2018)

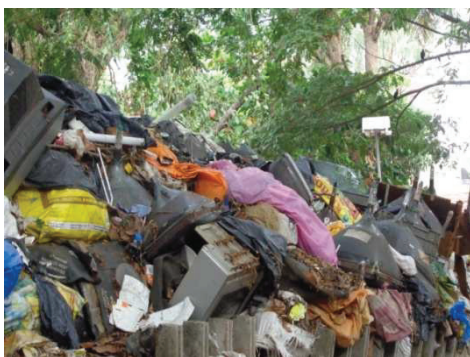
During site visits, huge quantity of E-waste was seen dumped at various⁶⁷ segregation, landfill and dumpsites. A few instances are depicted in the photographs below.

Segregation site of CCP at St. Inez
(17 May 2018)

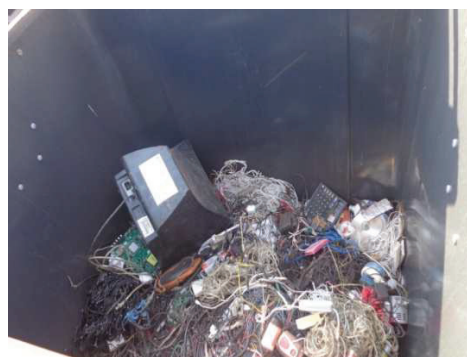
Segregation site of Mapusa MC
(05 July 2018)

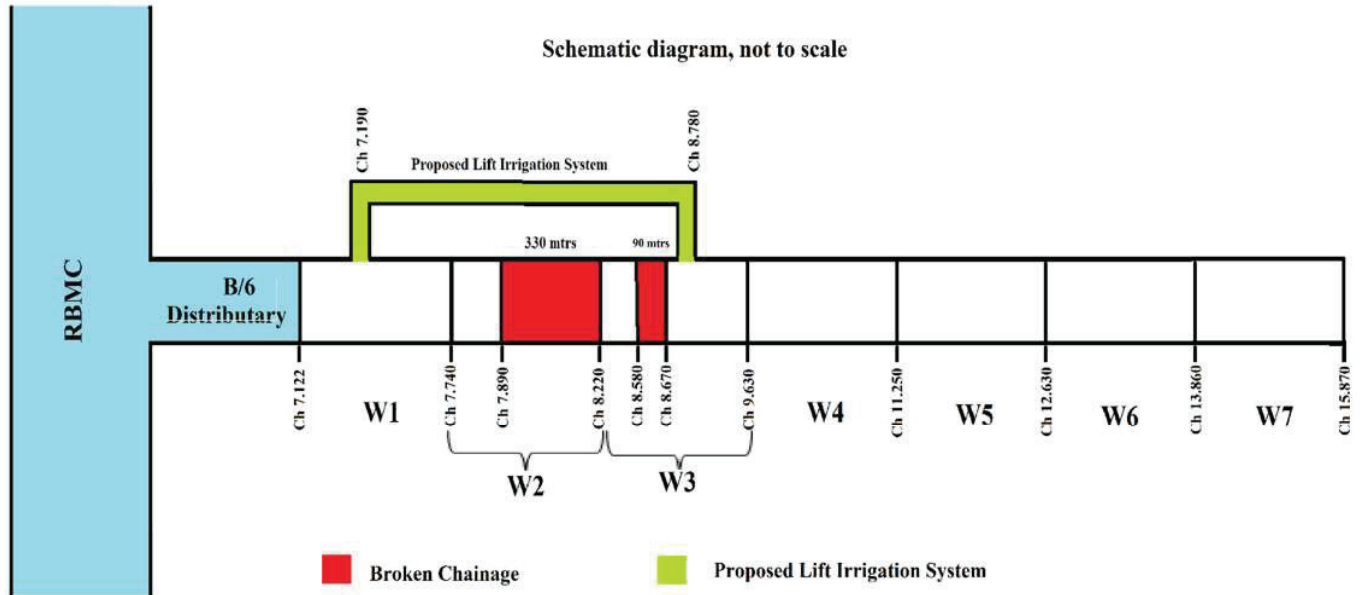
In order to connect the broken chainage of B/6 distributary, WRD decided (September 2018) to construct a lift irrigation (LI) system⁸⁰ for lifting water by pump from Ch 7.190 km to Ch 8.780 km (1.590 km) at an estimated cost of ₹ 6.38 crore. The work of LI system was awarded to a contractor⁸¹ in February 2019 at a cost of ₹ 5.84 crore for completion by November 2019.

A schematic diagram of seven works executed, broken chainages and new LI system is depicted below.
